Inspection Report

Minerals Regulatory Program

Mine Name: DKG Quarry
Operator Name: Diamond K Gypsum

Permit number: M0150041
Inspection Date: April 11, 2007
Time: 12:15-1:00 PM

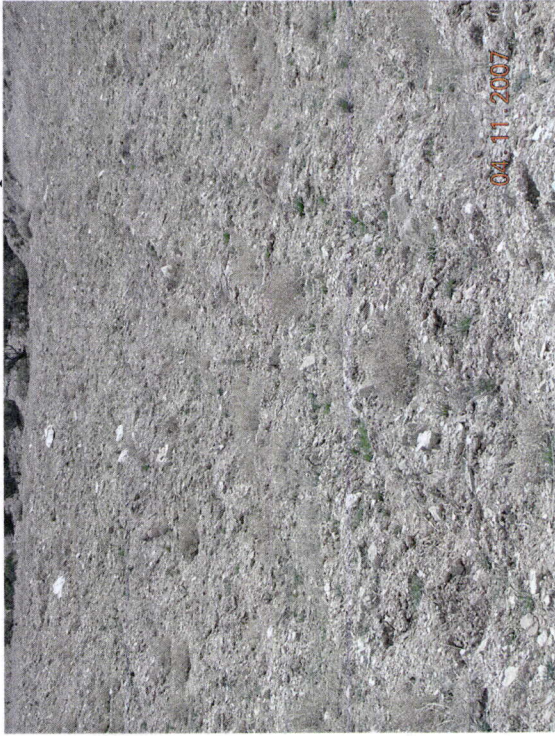
I measured vegetation cover in the area that was *re*-seeded in 2004 (Photo 1) and obtained a mean cover value of 7.1 percent for perennial vegetation. Nearly all of this was from grasses, mostly Russian wild rye.

Photo 1. This area was reseeded in 2004. Note the perennial grasses but the lack of shrubs.

The plan says the surrounding areas have 20 percent vegetation cover which would make the standard 70 percent of this value or 14 percent. In this case, the area reseeded in 2004 would not meet the standard. On May 30, 2003, I measured vegetation cover in undisturbed areas adjacent to the mine and obtained a value of 6.7 percent. If this is the appropriate value to use toward the standard, the reseeded area has enough vegetation and could receive final release.

I suggest that the operator re-evaluate vegetation cover in undisturbed areas near the mine and also that they measure cover in the reseeded area at the same time and by the same observer for an accurate comparison.

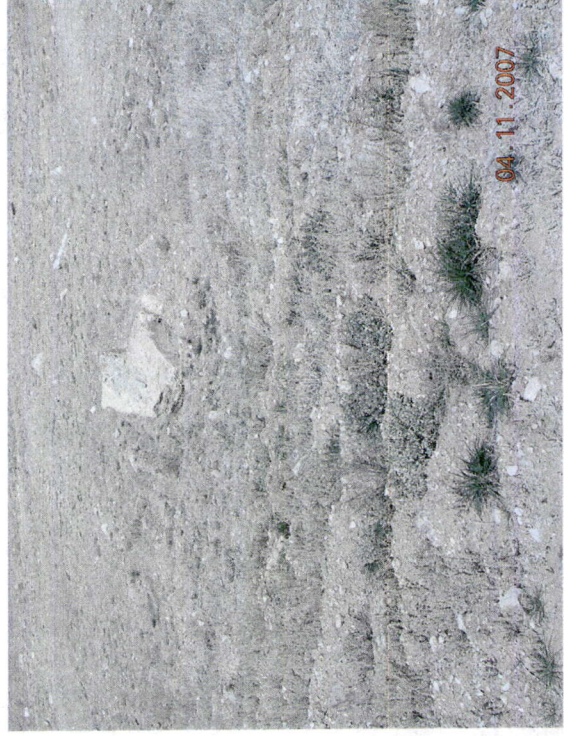
I did not measure cover in the area that was newly seeded in 2004, but this area continues to progress well (Photo 2). While it contains a lot of grasses, the dominant plants are shrubs, especially Castle Valley clover and fourwing saltbush.

Photo 2. This area was newly seeded in 2004 and has a lot of shrubs and perennial grasses.

The area that was newly seeded in the fall of 2004 is potentially eligible for full release this year.

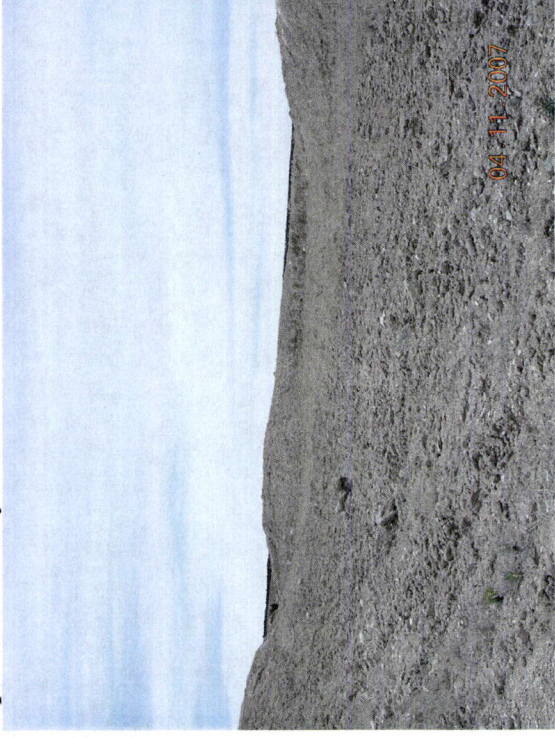
Vegetation in the area regraded and seeded in 2005 is not doing as well (Photo 3). Some areas have a lot of perennial grasses, but most of the area is barren except for weeds. I felt the operator did a good job grading, roughening and seeding this area, but the weather did not cooperate as well as it did in the winter/spring of 2004-2005.

Photo 3. This area was graded and seeded in 2005 and has little perennial vegetation.

If the operator does reclamation work this coming fall, I suggest that they consider reseeding the area that was seeded in 2005.

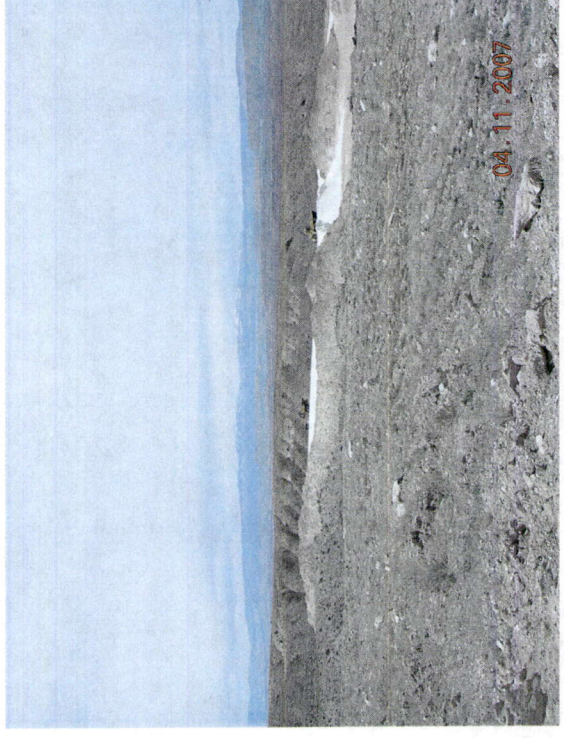
The mine was active at the time of the inspection (Photo 4), but I did not look closely at the mining area.

Photo 4. In the distance is the active mining area.
